**MARYLAND HISTORICAL TRUST
DETERMINATION OF ELIGIBILITY FORM**

Property Name: Bloomsbury Avenue Gatehouse, Spring Grove Inventory Number: BA-2323
Address: Spring Grove Hospital City: Catonsville Zip Code: _____
County: Baltimore County USGS Topographic Map: Baltimore West
Owner: DHMH Is the property being evaluated a district? _____ yes
Tax Parcel Number: _____ Tax Map Number: _____ Tax Account ID Number: _____
Project: _____ Agency: _____
Site visit by MHT staff: _____ no X yes Name: L. Bowlin, 1985 Date: _____
Is the property is located within a historic district? X yes _____ no

Bloomsbury Avenue Gatehouse

State Historic Sites Inventory Form

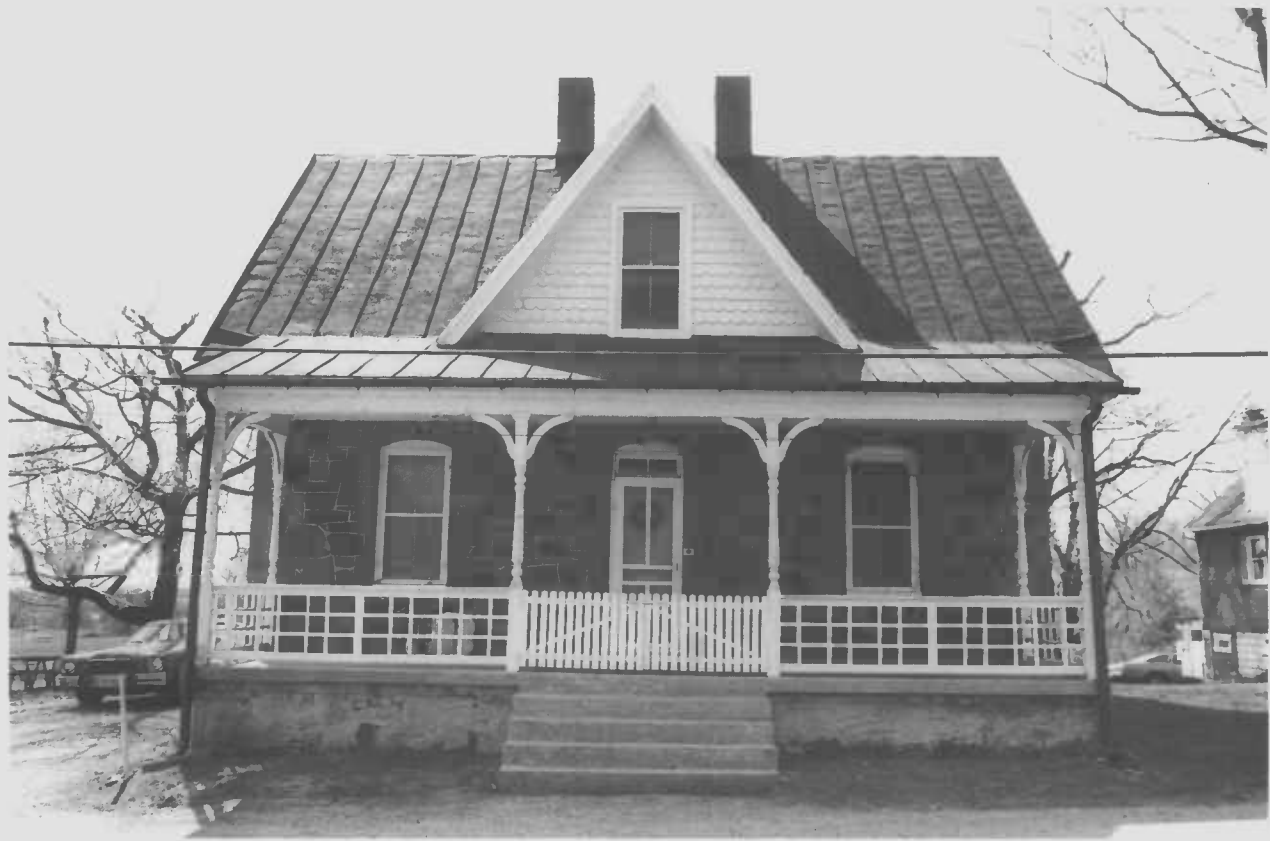
NORTH WALL

The northern facade is three bays wide, two bays deep. A wooden porch with a rubblestone foundation projects outward from the facade. The porch is framed by a wooden balustrade and turnposts. A simple design adorns these wooden elements. The porch has a wooden picket gate which opens to cement steps. The porch roof is tin as well.

The edges of rubblestone walls of the building have irregularly cut granite quoins. Though slightly darker in color, the quoins are difficult to distinguish from the rest of the rubblestone. Red bricks provide color contrast as they form Gibbs surrounds for the windows and door. A segmented arch lintel caps the openings. The 2/2 sash windows have wooden sills and surrounds. One window flanks each side of the doorway. The windows and the door have a carved wooden transom; the same design which matches the other transom on the gatehouses and the firehouse. The main door has an additional glass transom below the wooden detail. The entrance has both a screen door and a solid wooden door.

A cross gable juts out from the roof. Shiplap siding covers the face of the gable. Plain, exposed verges characterize the gable. There is a central window with a 2/2 sash. Two central, interior chimneys break the roof line just east of the gable. The individual chimneys are constructed of red brick.

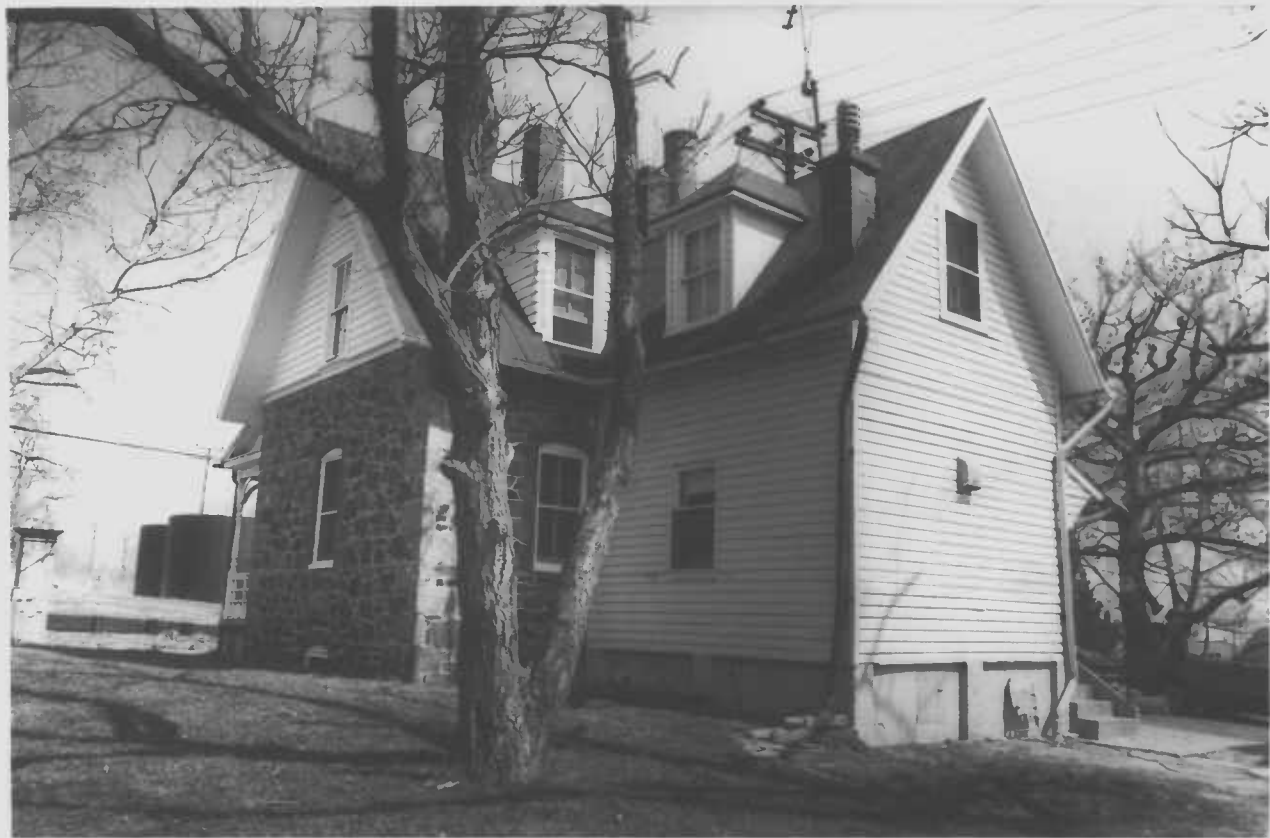
WEST AND SOUTH WALL

The architectural details of the western, eastern and southern faces of the rubblestone portion of the building are very similar. The ground level window wells have a two pane window with outer screens and the carved transom. A segmented arch brick lintel completes the description. The southeastern face reveals only the crest of the segmental arch lintel due to the wooden cellar entrance. The first floor windows have the same detail as the northern windows: Gibbs surround, wooden sill, carved transom, and segmented arch lintel. Shutter fixtures are visible. The west and east face have simple gabled ends with plain, projecting verges. The shiplap siding covers the gable ends. The centrally located windows have a 2/2 double-hung sash. They rest just below a triangular air vent. The louvered vent is formed by the peak of the gable. A hip dormer projects from the southern face. Built in clapboard siding, the dormer has a tin roof and 2/2 double-hung sash window with a simple wooden surround.

The clapboard addition rests on brick piers with additional concrete reinforcement. The addition is two stories with a tin roof. The western side of the addition has a very simple window with a lower sash screen. A hip dormer protrudes from the gable roof. The dormer has metal sides and a small portion of clapboard on its face. The 2/2 double-hung window remains plain. The addition has its own interior chimney on the western face. The southern side of the addition has a simple gable end with plain, projecting verges. A second story window matches the window on the western face.
